# Dredging

# INTERFLON

MicPol® Lubrication Technology

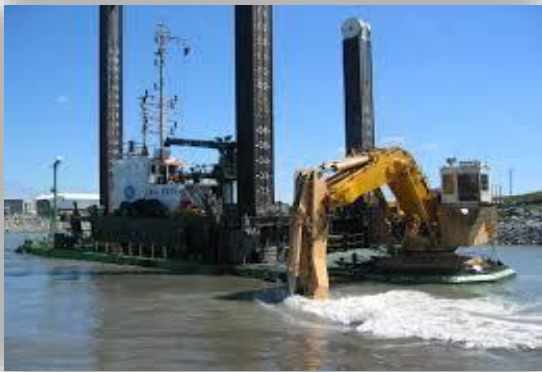
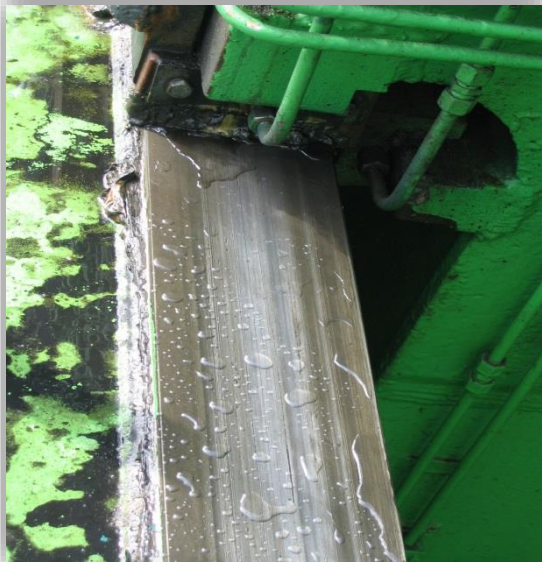
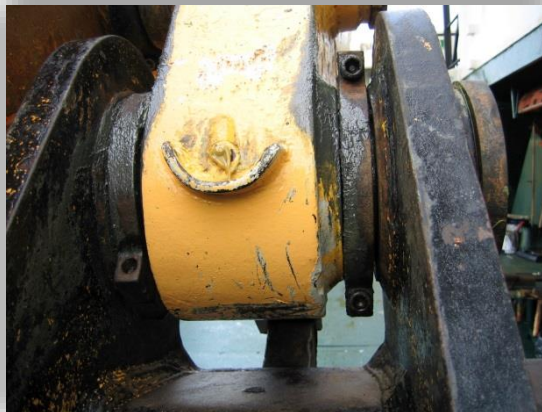
## Application; Backhoe Dredger horizontal guides spud carriage

Lower guides under water.  
Upper guides - splash water.  
Lubricant is constantly rinsed out.  
Very high grease dosing, up to 30 L/day  
(continuous lubrication while the pontoon is in service).

Extreme wear of the bronze skids (30 mm). Worn away completely after 5 years!  
The mounting bolts tear the horizontal guides to pieces. Especially the lower guide tracks and skids are subject to wear. Lubricating channels are literally worn away.

- Grease consumption reduced 20-fold
- Grease seawater resistant (no rinsing)
- Wear on skids 2 to 3 mm
- Mounting bolts intact
- Lubrication grooves in new condition
- Cost saving balance: €620,000.00

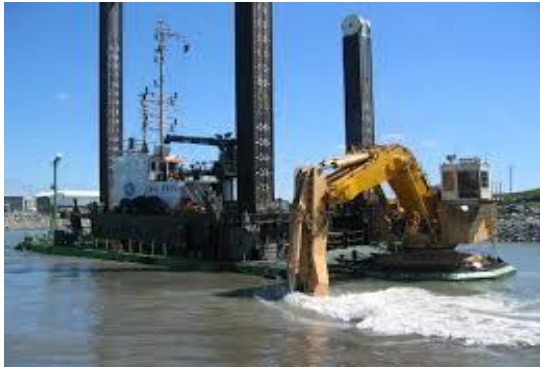
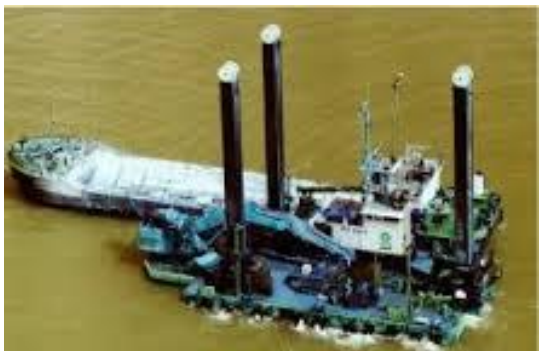
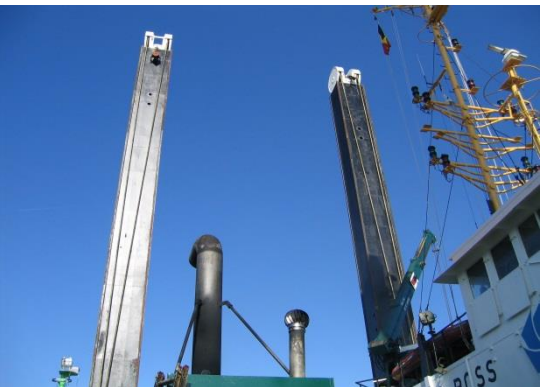
## Application; Backhoe Dredger vertical guides spuds

The grease is rinsed out by the seawater. After 8 weeks, the lubricating film has disappeared completely. Sometimes, the grease is already gone after just a few spud movements.

A high greasing frequency cannot be maintained; when the pontoon is in service, lubrication is not possible.

The maintenance is a very dangerous task because the location where the lubrication needs to take place is very difficult to reach.

- The grease is no longer rinsed out by water
- The grease withstands the very high friction forces
- After lubricating once a week for a few weeks, the interval has been established at once a month.
- The gigantic noise problem is solved forever / People on board are enthusiastic
- Strongly reduced product consumption
- Huge cost reduction!!!

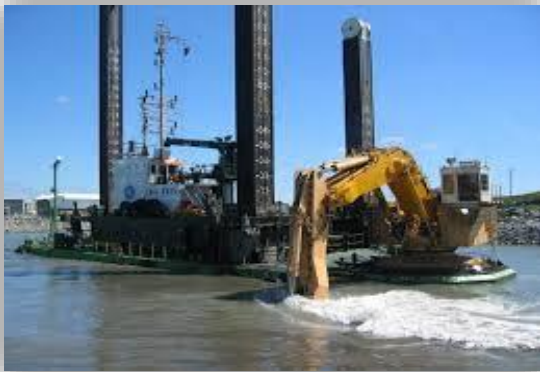
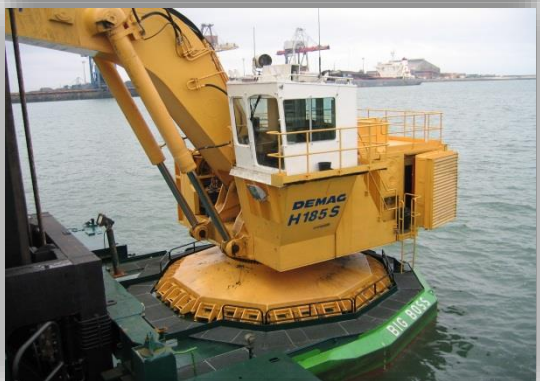
## Application; Backhoe Dredger bucket manual lubrication

Lubrication interval 2 hours. Each lubricating service takes about 15 minutes. Despite being lubricated so much, there is extreme wear on the shaft bushes of the linker and rocker.

- Lubrication interval extended from 2 hours to 8 hours
- Costs reduction of €1,250 per working day
- After working in a sandy floor (Beernem - B), the shaft bushings were disassembled and the tolerances were the same as those in a new condition
- There was a clearly present grease seal which prevented silt and water entering

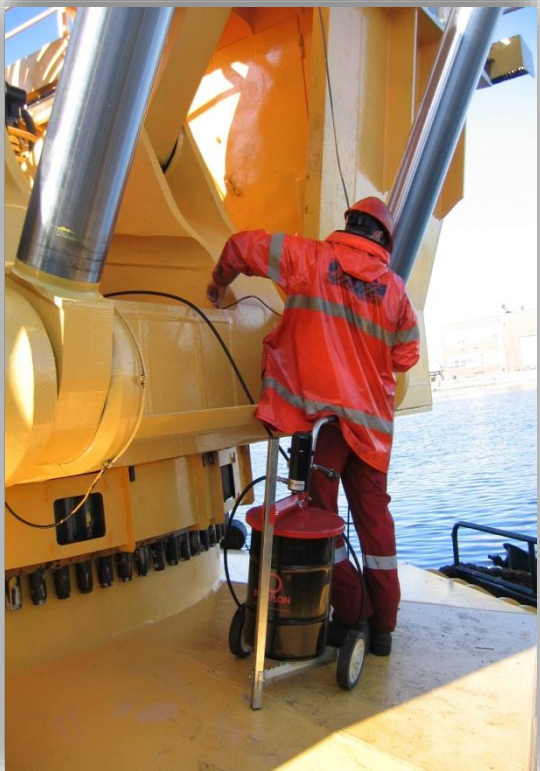
In service, the grease disappears quickly because the bucket works underwater (a lot of silt).

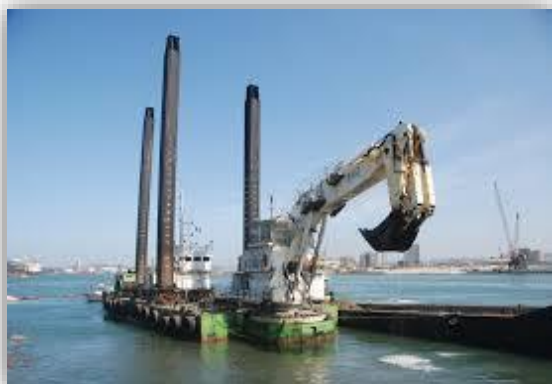
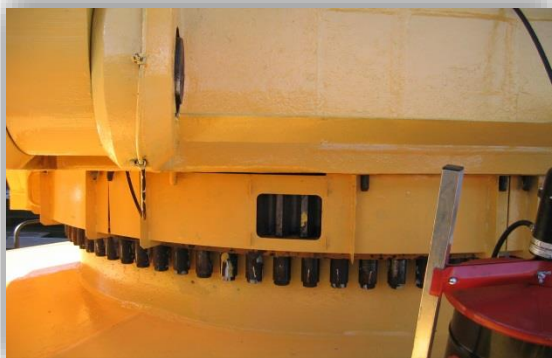
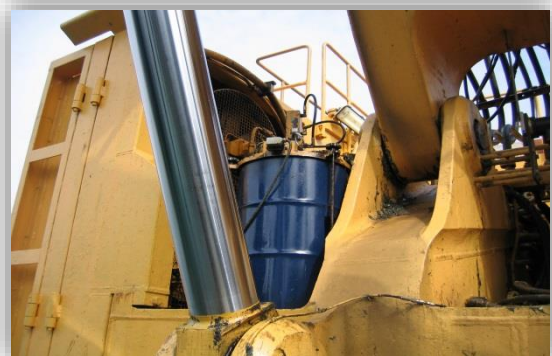
## Application; Backhoe Dredger crown gear

Central lubrication of mono cylinder and crown gear bearing.

Excess grease consumption: 200 L / 2 weeks / lubrication interval 20 minutes.

- Lubrication interval extended from 20 to 180 minutes
- The grease from the shaft bushings is still in perfect condition
- Much less grease on board
- Much less environmental impact
- Substantial reduction of shaft bushing wear
- Much less work filling the lubricating systems

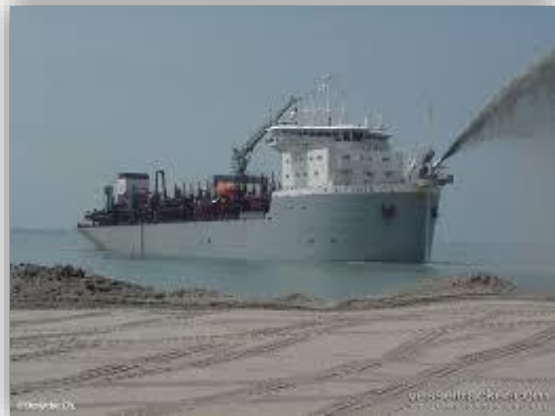
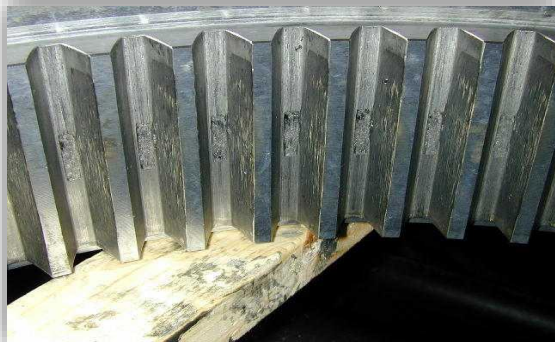
Application; Trailing suction hopper dredger quadrant couplings dredger pump

Extreme wear of the quadrant couplings due to friction in the longitudinal direction of the teeth. Serious damage after 2 years of service. Expensive repairs.

- Since Interflon Grease LS2 has been used, the damage has been halted and a clear improvement can be seen (after visual inspection)

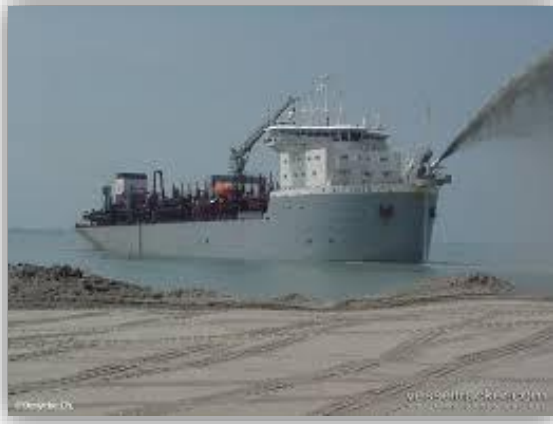
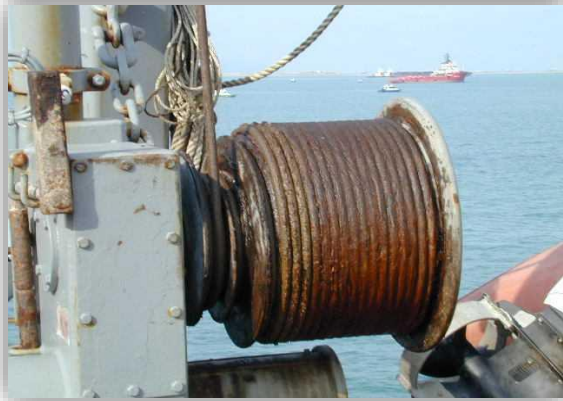
**Application; Trailing suction hopper dredger cables suction pipe mobb, life-boat**

Salty seawater penetrates the cables.  
Cables begin to rust internally and strands break.  
The existing grease provides insufficient protection and disappears quickly.

- Core lubrication takes place with Interflon Lube TF. This product easily penetrates to the core of the cables and lubricates each individual cable strand
- Interflon Grease LS2 provides an excellent protection of the exterior cable. The grease is no longer rinsed out by water
- No more internal rusting and much less strand breakage

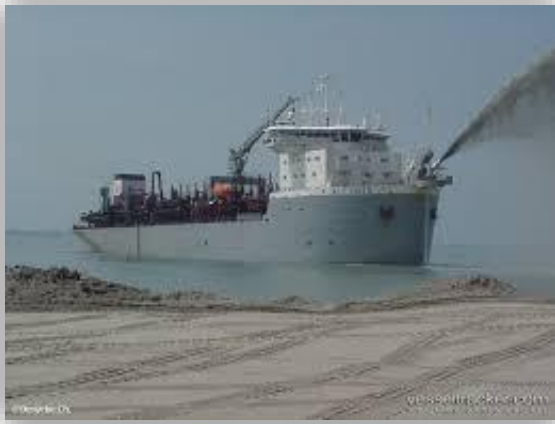
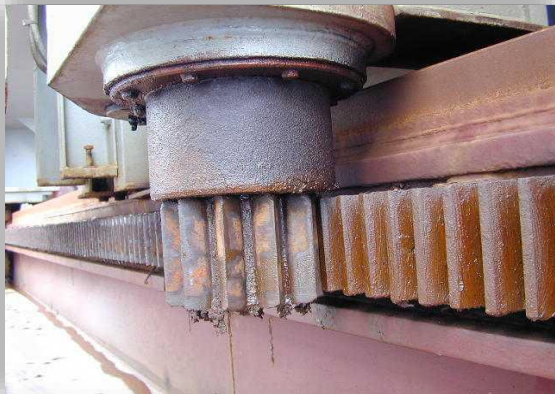
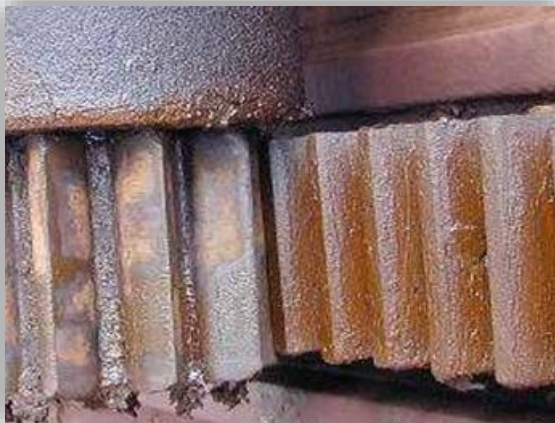
Application; Trailing suction hopper dredger Deck crane rack and pinion

Lubricating film disappears after 1 month.  
Creaking and squealing noises.  
Rusting.  
Frequent re-greasing.  
Environmental impact.

- The lubricating film is still visible after 3 months
- No more creaking and squealing noises
- Clean, dry and transparent lubricating film: surface can be inspected

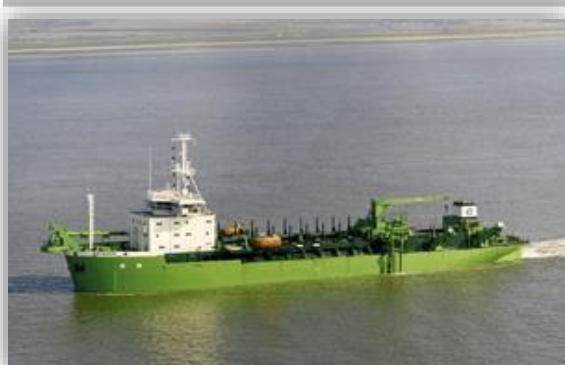
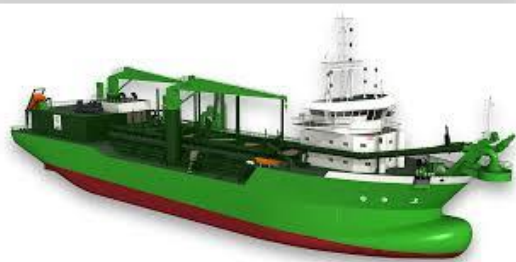
Application; Trailing suction hopper dredger Suction head winch / suction pipe

Excessive wear of the tooth flank due to high friction.

Risk of fracture and unexpected downtime.

- Additive mixed with a static mixing pump = homogeneous emulsion
- The wear process (pitting) is stopped after adding additive (visual inspection - identical working conditions)
- The noise produced is greatly reduced
- Objective: reliability has been achieved!!!

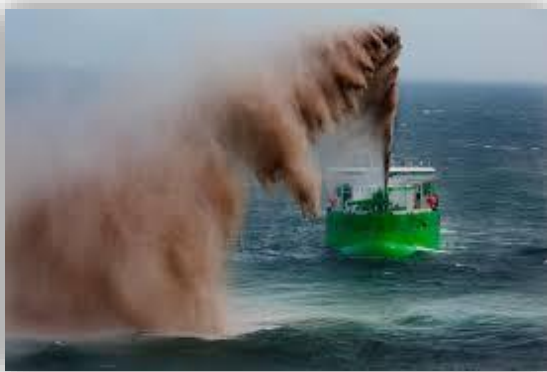
Congo River

Shaft bushing blocks, runner wheels, bearings and the skid guides.

Automatic lubricating system.

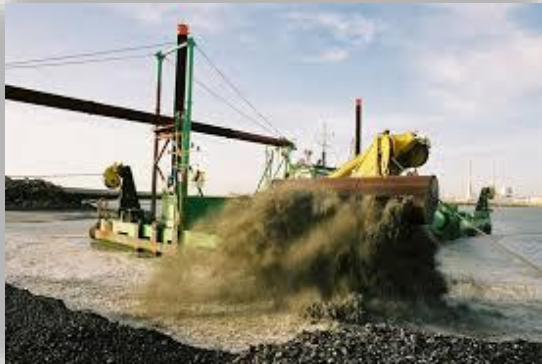
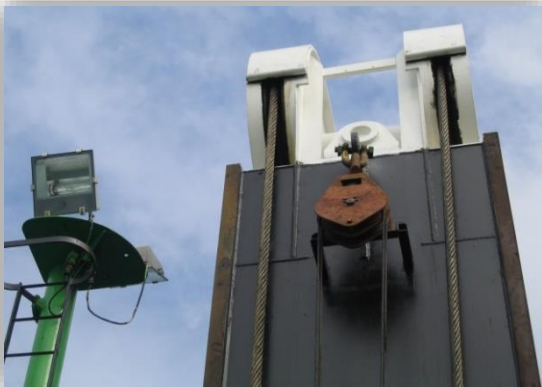
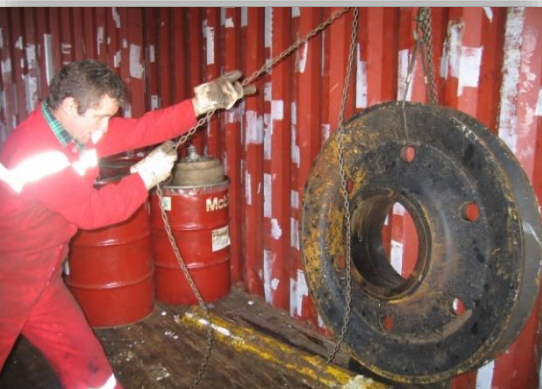
## Application; Spray pontoon Runner wheels

Extreme wear of the new runner wheels (especially the lower). Bearings become dislodged.

Expensive repairs up to €35,000 per spud.

- Lubrication interval stretched to 24 hours
- No more creaking bearings, even after 2 days of not lubricating
- Visual inspection after 3 months of working with Interflon Grease LS2: almost no more wear
- The creaking noise ceased after the first lubricating service, and has never returned
- Crew on board: from sceptical to enthusiastic

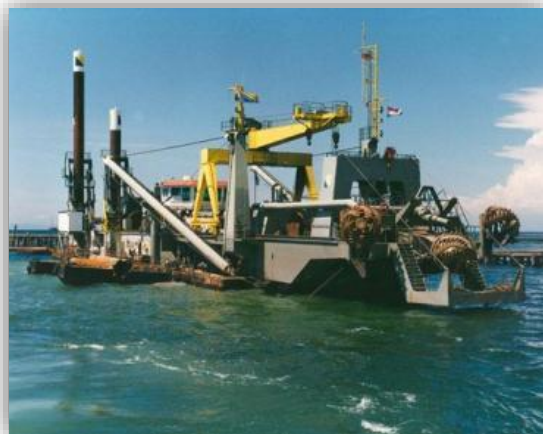
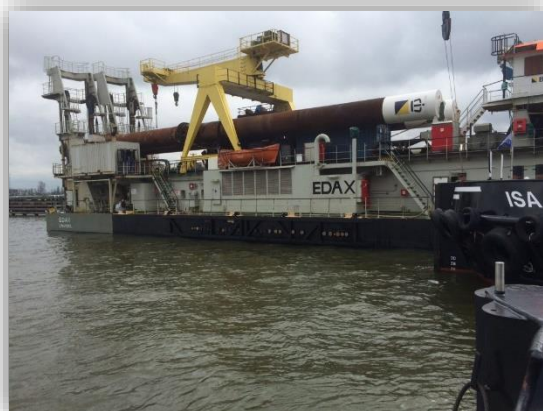
**EDAX**

Lubricate the spuds and via long pipes on the ladder to the cutter.

Proven that our Interflon Bio Grease MP2 can handle - 35°C, better than the present XHP222.

Due to the low temperature, - 15°C, the pressure in the pump has risen (normally 180 bar, now above 200 bar), but it functions well.

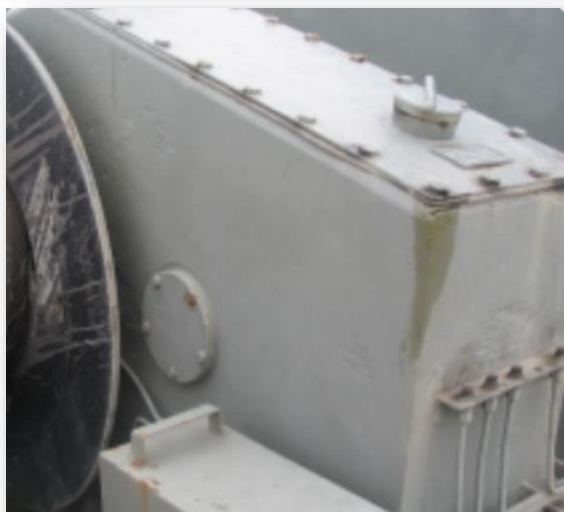
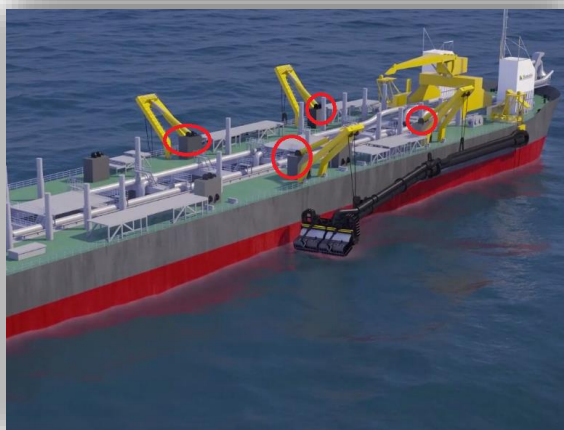
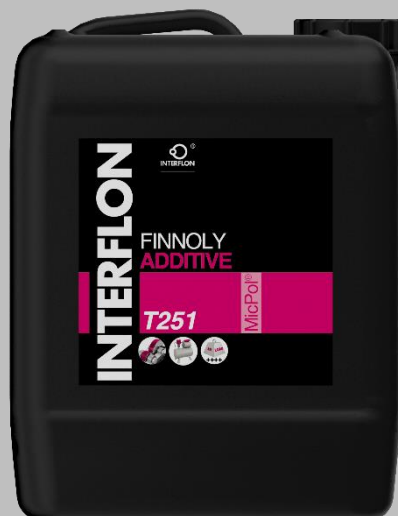
## Application; Gearbox of the suction head winch

Wear on the teeth flanks. The extreme and fluctuating loads cause an interrupted oil film. Many oil changes.

- The wear almost imperceptible
- Gearbox noise is reduced
- Oil temperature has dropped at least 10%.

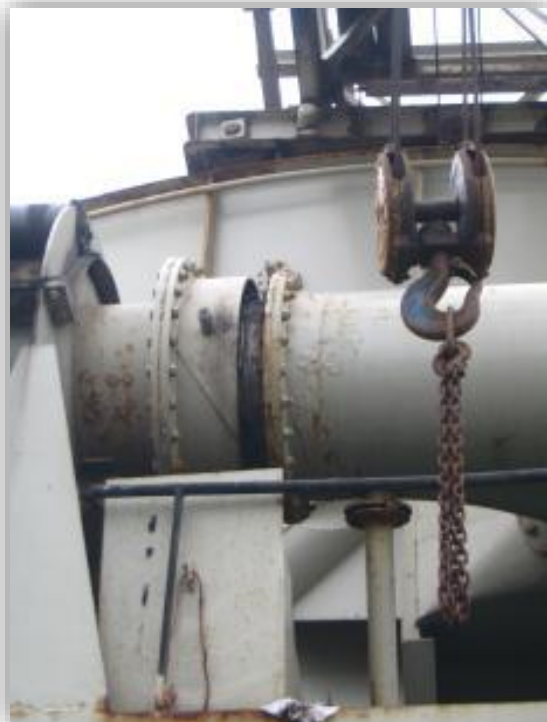
The currently used greases are rinsed away by seawater and are often unable to withstand the forces.

- Grease consumption has dropped by 75%
- Water resistant
- Environmental pollution is kept to a minimum

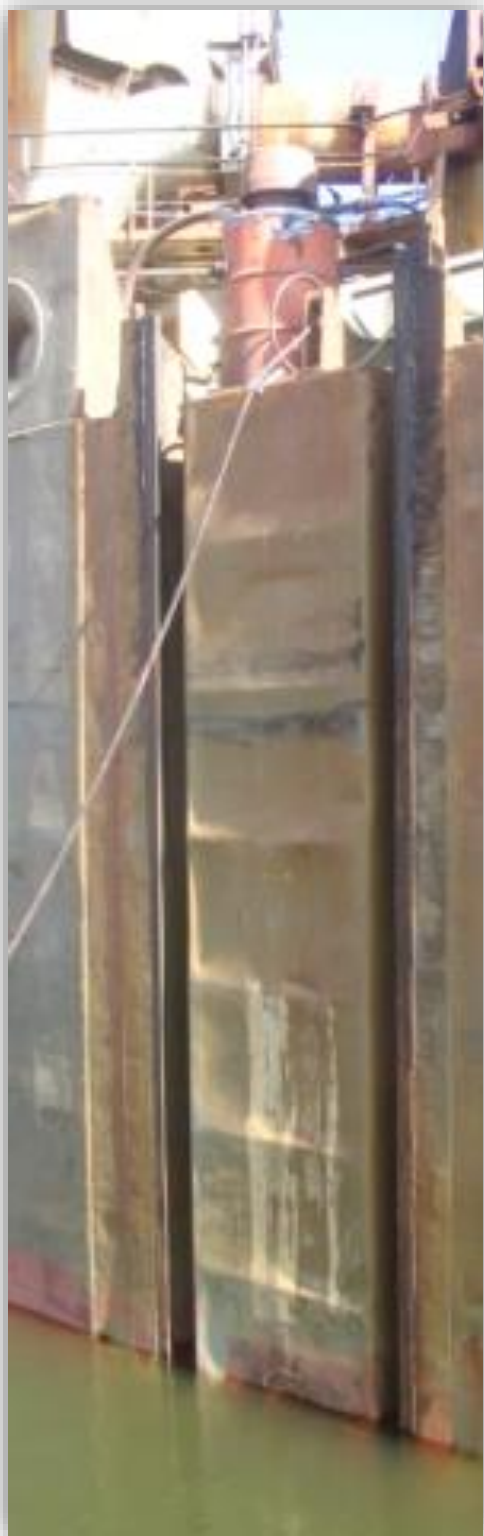
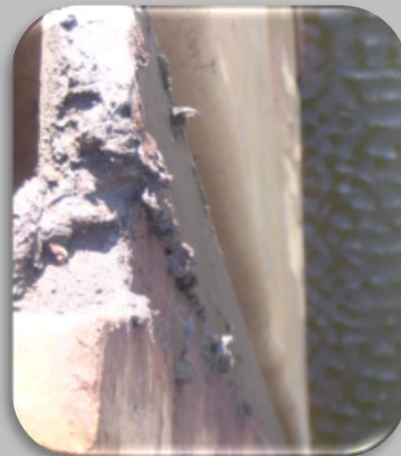
High environmental impact due to saponification of conventional grease.

Despite a high consumption of grease, a lot of rusting occurred.

- Rinsing away is a thing of the past
- Less grease consumption
- Less environmental impact
- Less labour (in bad weather)
- Much less frequent lubrication
- Time savings

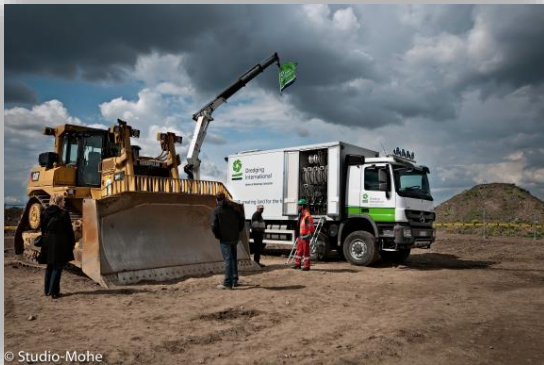
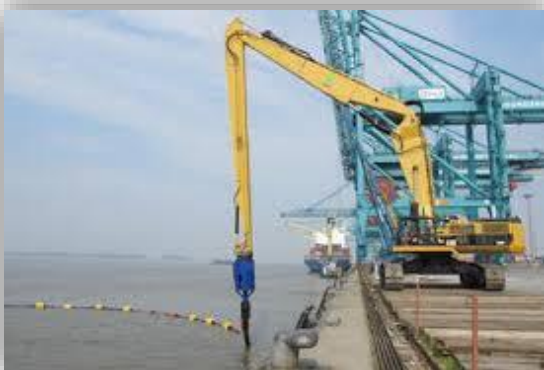
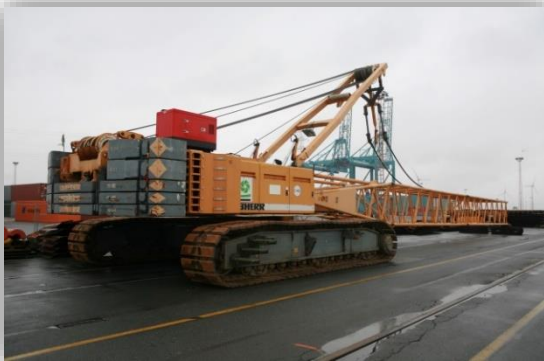
## Application; Equipment - shaft bushings, cardans and bearings

Frequently damaged shaft bushings / very difficult to disassemble (up to two days work).

High equipment and repair costs.

- Lubrication interval extended to weekly
- Maintenance carried out by technicians and no longer by operators
- No longer any damaged shaft bushings
- Substantial reduction in the wear process
- No more expensive repairs
- Much higher reliability of the machinery

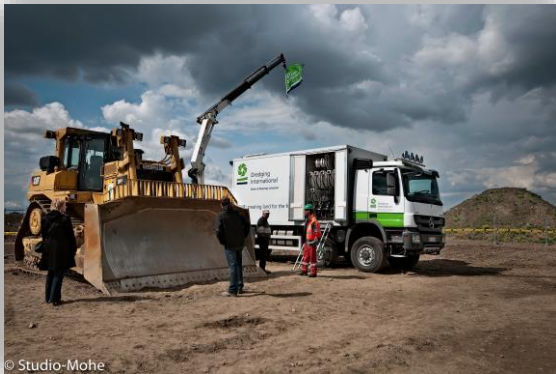
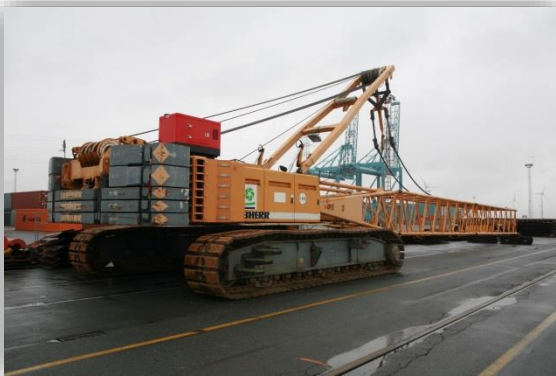
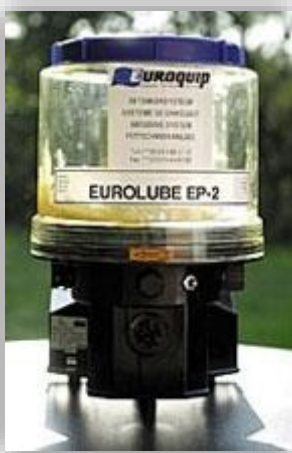
## Application; Equipment – Central lubrication systems

Grease often hardened in the lubricating pipes /  
expensive repairs by mobile service technicians  
(Euroquip).

Often damaged shaft bushings / very difficult to  
disassemble (up to two days work).

- Lubrication frequency: ST 2 min. / WT 4 h  
(reduced by a factor 8)
- Grease consumption: approximately 800 L /  
fewer stops at the workshop to fill the  
lubrication systems
- The grease is stable and does not harden /  
Euroquip interventions are a thing of the past
- Savings only in working hours: €40,000
- Substantially lower repair costs

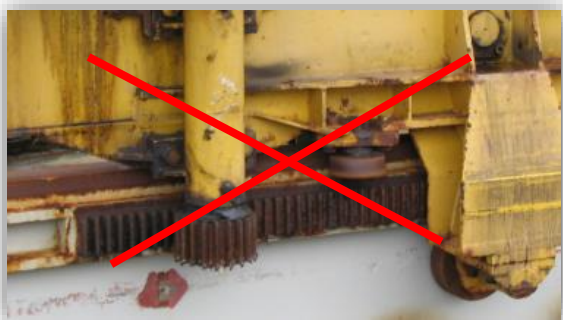
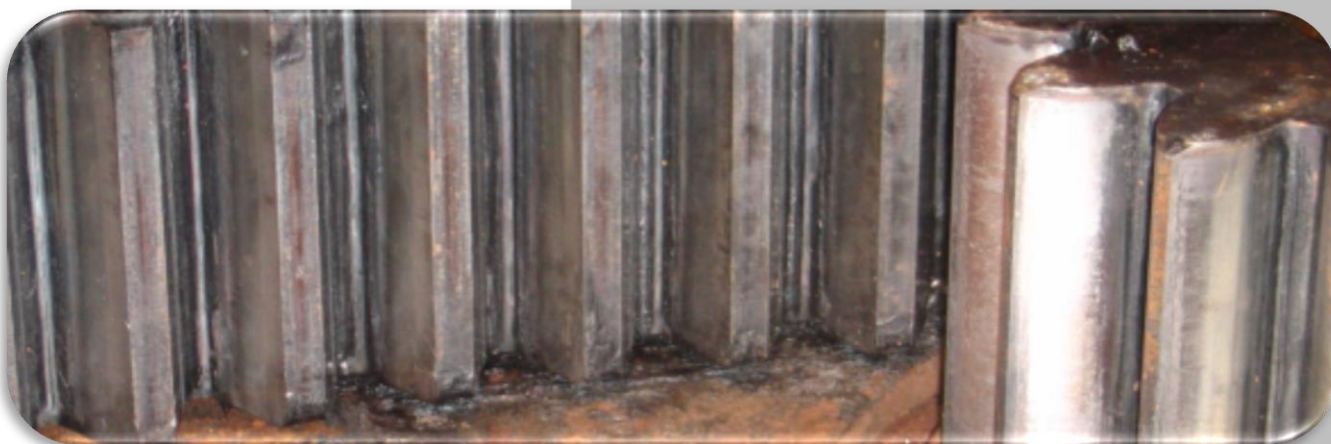
## Application; Open gears , tracks and gear rings

Lubrication often and with black grease that drips in the summer and crumbles in the winter. We often see rust under these greases and the teeth cannot be inspected. Rust occurs when the lubrication is insufficient.

- Transparent lubricating film
- Damp-proof
- The teeth are easy to inspect.
- Temperature range from -20 to + 150°C

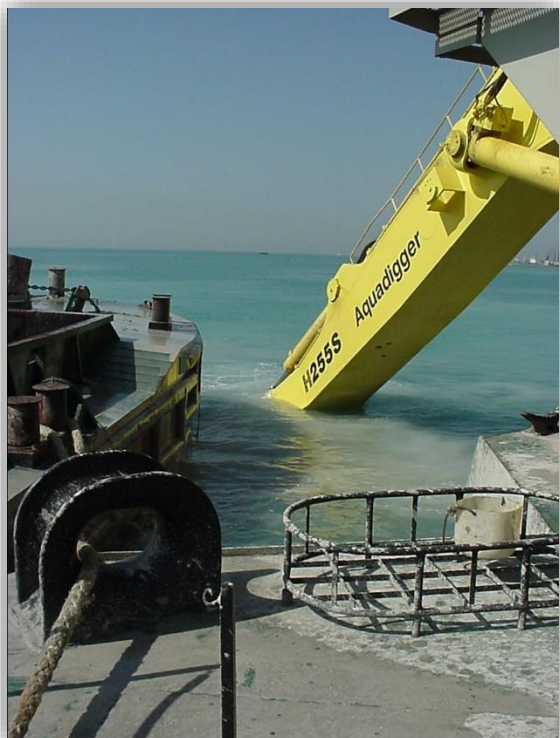
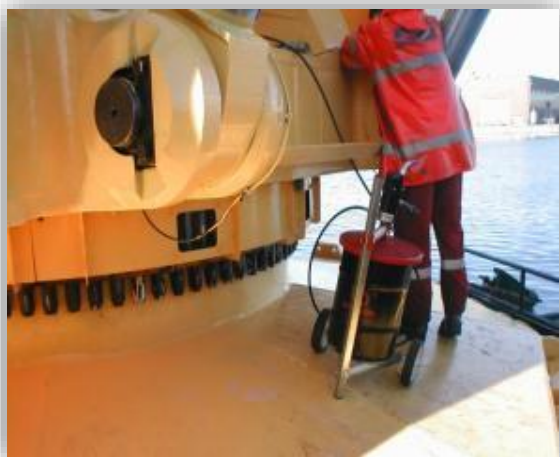
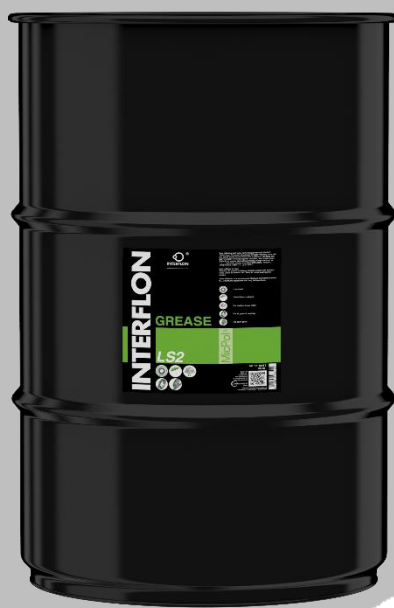
## Application; Turntable Aquadigger H255S

High grease consumption due to displacement and rinsing away by (sea)water.  
Consumption about 200 L every 14 days.

- Grease consumption is reduced by 75%
- The rinsing away and displacing of the grease is a thing of the past.

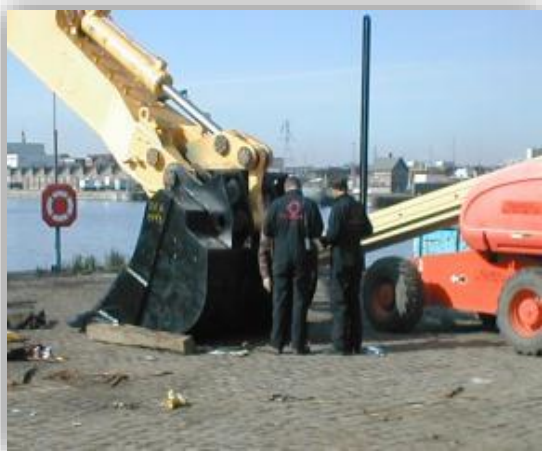
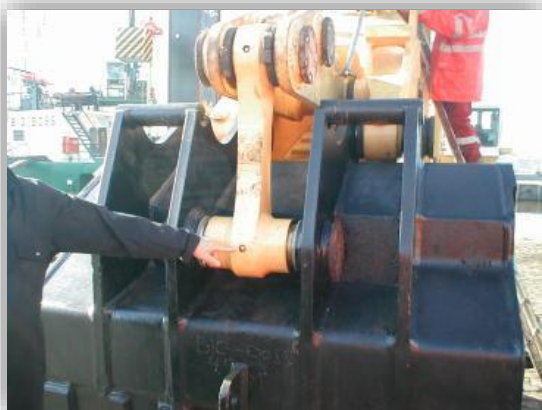
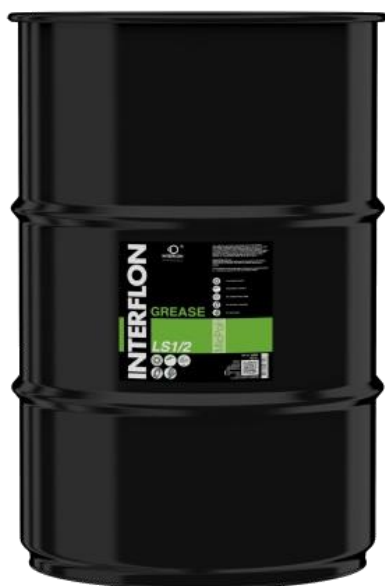
## Application; Pin-bush connection Bucket

High grease consumption because conventional grease was displaced and rinsed away by the seawater.

Wear and grease consumption pin-bush connections.

- Grease consumption is reduced by 25%
- wear of the pin-bush connection has been reduced by a factor 6

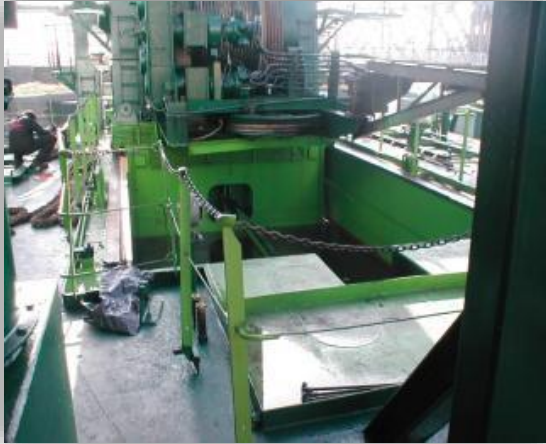
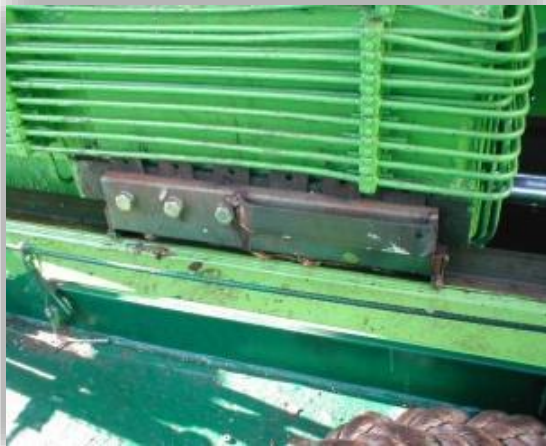
## Application; Spud carrier guides

Conventional grease is rinsed away by (sea)water. Regular re-lubricating is a must. The wear of the guide strip was 30 mm in 6 years.

- The grease consumption has decreased from about 8,000 L Mobil to 300 L Interflon Grease LS2.
- The wear of the guide strip has been reduced in 6 years to 3 mm. (10%)

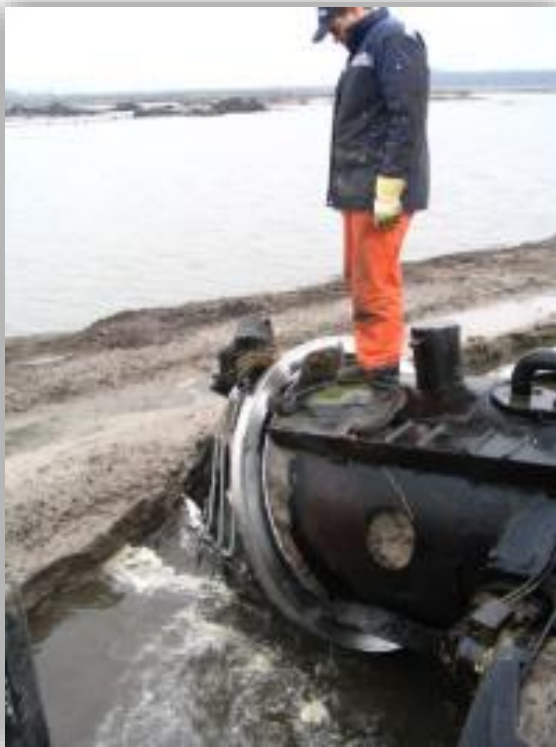
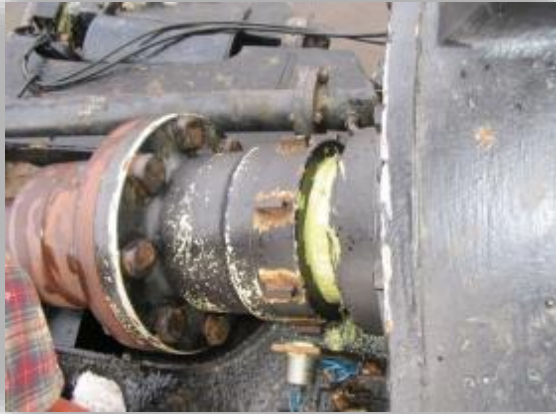
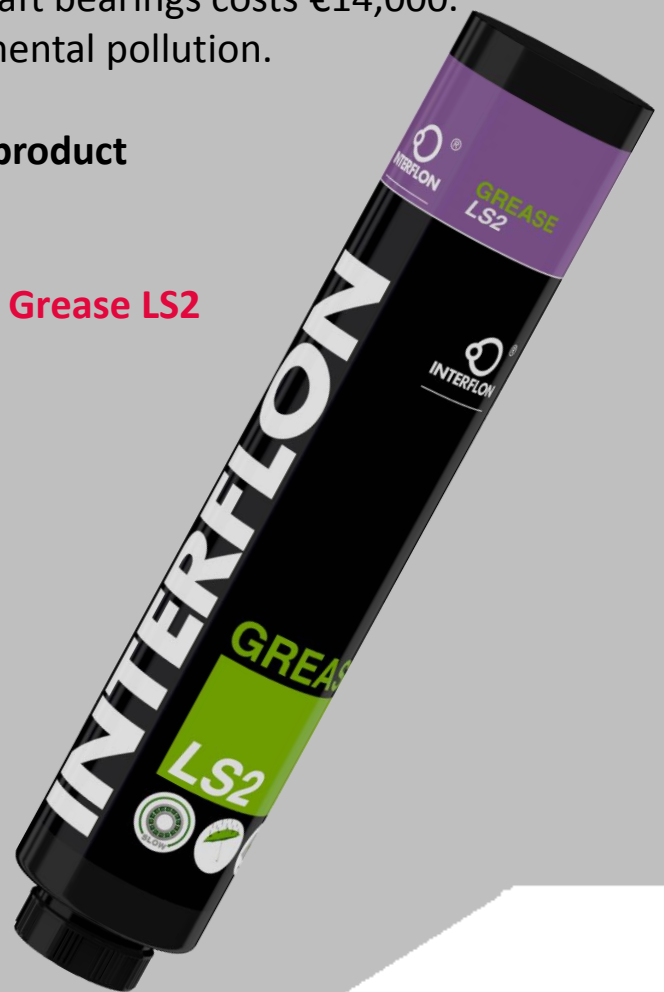
## Application; Cutter shaft bearings

Grease quickly disappears (rinsed away) and frequent lubrication is required (the grease saponifies).

High grease consumption of 8 L in 11 hours. Bearing wear, and the replacement of three cutter shaft bearings costs €14,000. Environmental pollution.

- Consumption to 8 L a week; 80% less.
- Grease does not saponify.
- No, or almost no bearing wear
- Less environmental impact

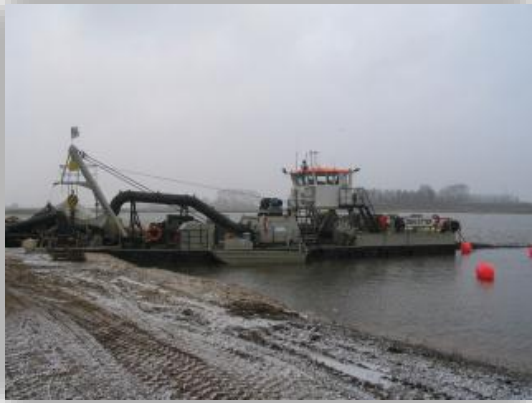
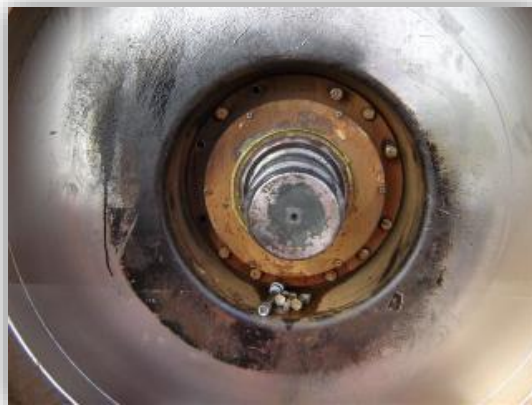
## Application; Gland sand pump

Lubricating the sand pump gland with Interflon Grease LS2 has had a positive effect. Upon inspection for wear of the walls, the impeller still appeared greased. On disassembly of the protective plate, the chrome rings still appeared to be properly greased. On disassembling the ring, it appeared that there was also almost no wear and the same ring was reinstalled.

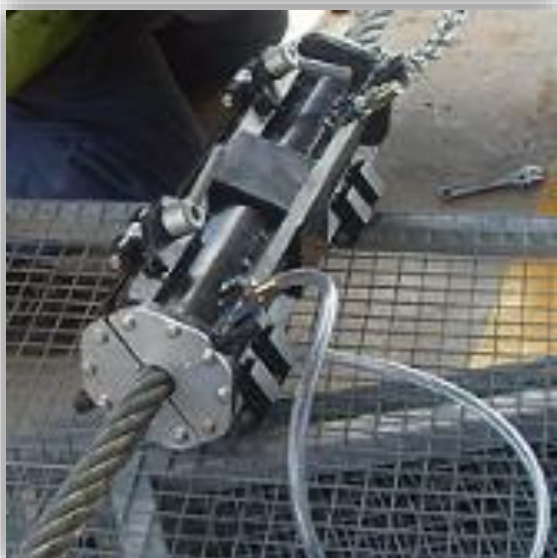
The option to lubricate with a cable greasing system.

Broken cables, corrosion on cables and hardened grease. Average service life of the cables was just 2 years. Conventional grease was discharged in the water, weekly lubrication was needed resulting in high environmental impact.

No more rusting since Interflon Grease LS2 is being used. The cables now only have to be lubricated once every six weeks instead of weekly.

The service life of the cables has been extended from 2 to 6 years.

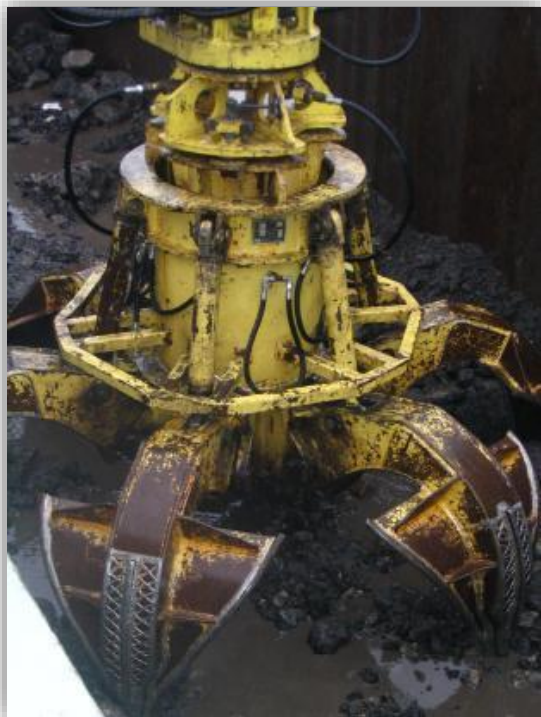
## Application; Polyp or bucket grab

- Grease saponifies
- High grease consumption
- Wear
- Environmental pollution

- Less consumption = 75% less.
- Grease does not saponify.
- No, or almost no bearing wear
- Much less environmental impact

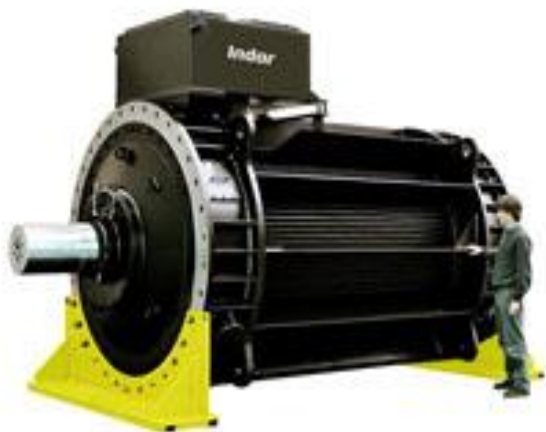
**Application; Indar Bakker oil filled submerged motor****1-5**

Mandatory to use bio-degradable oil which performs less well than mineral oil. The existing oil absorbs too much water, causing malfunctions. These malfunctions are very expensive because the motor needs to be exchanged.

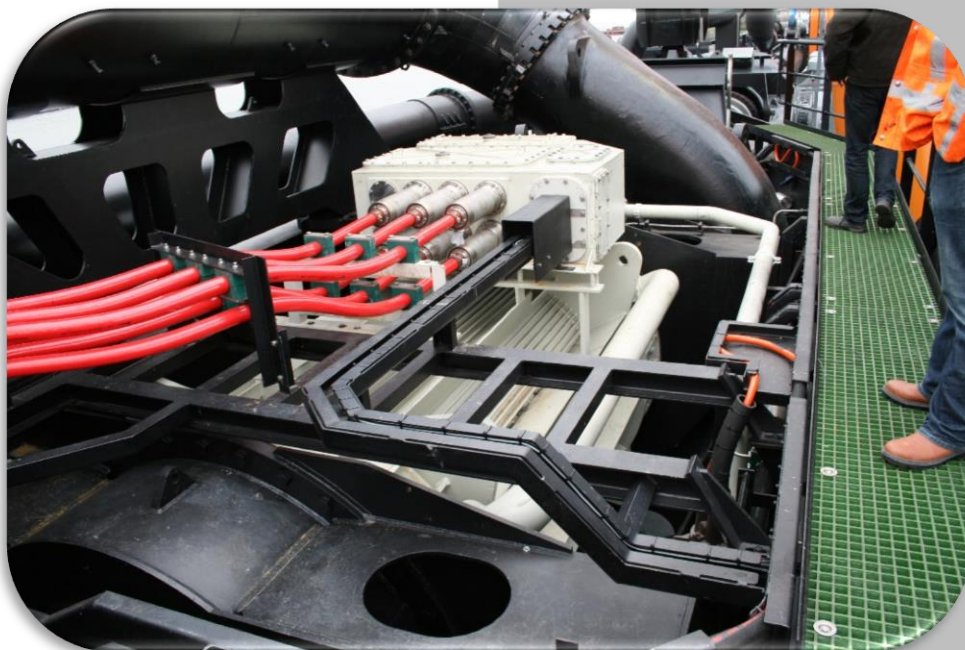
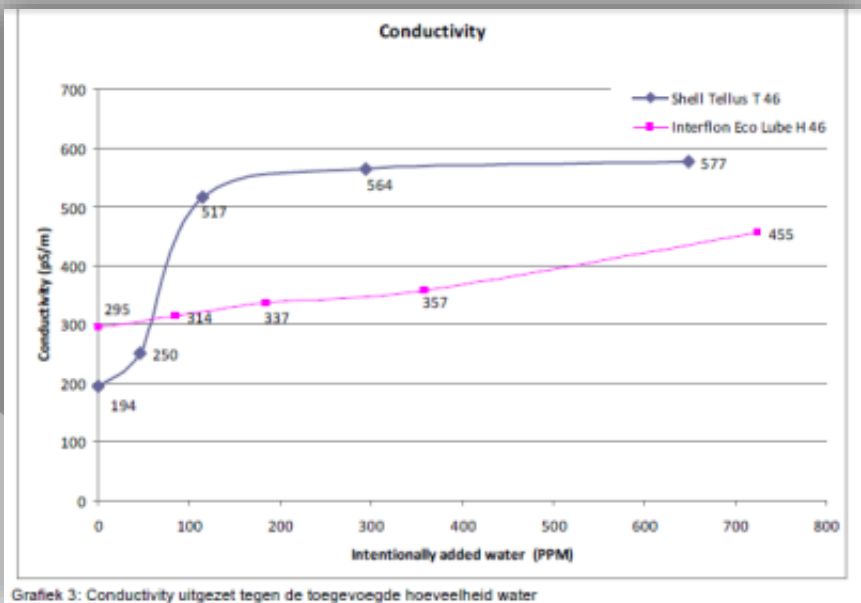
The effect of the addition of water to the Interflon Eco Lube H46 is a slight increase in the conductivity. *The measure of the conductivity of electricity.*

From this graph we can conclude that a small amount of water substantially decreases the Dielectric Strength of the Shell Tellus T46. The effect of the addition of water to the Interflon Eco Lube H46 is a much smaller decrease of the Dielectric Strength.

From this graph we can conclude that a small amount of water strongly increases the conductivity of the Shell Tellus T46. The effect of the addition of water to the Interflon Eco Lube H46 is a slight increase in the conductivity. *The measure of the conductivity of electricity.*

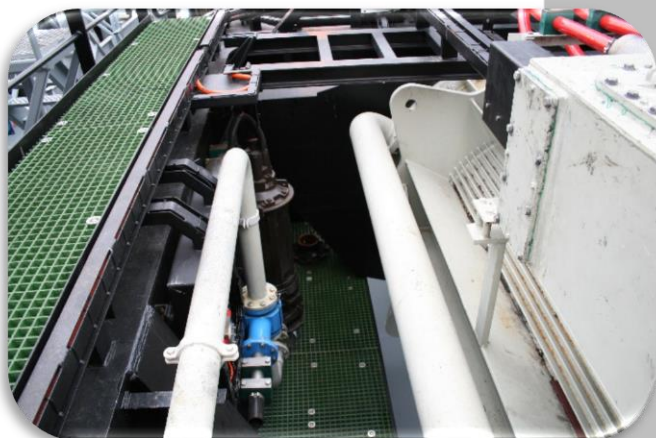
Side view

## Application; Indar Bakker oil filled submerged motor

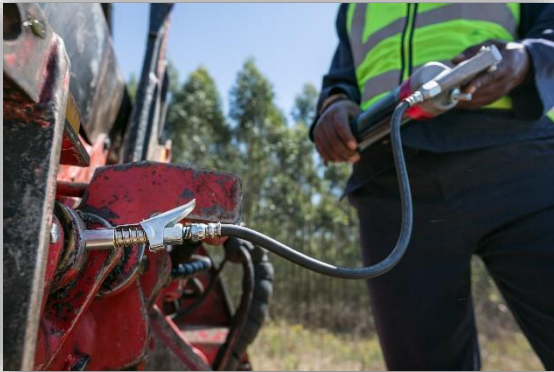
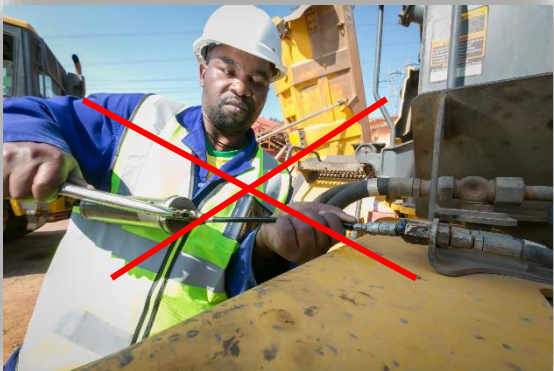
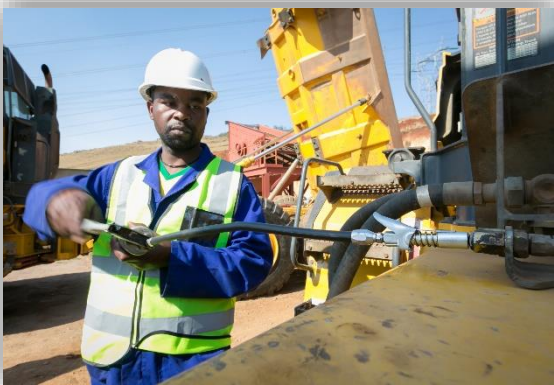
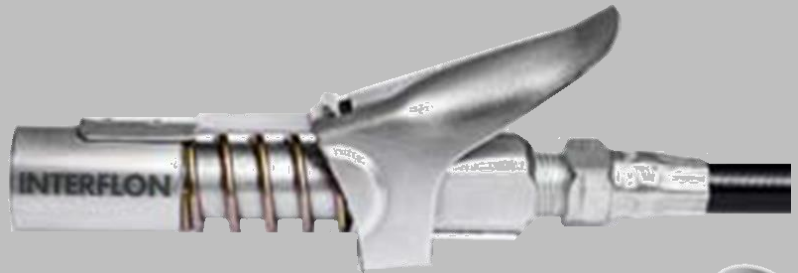
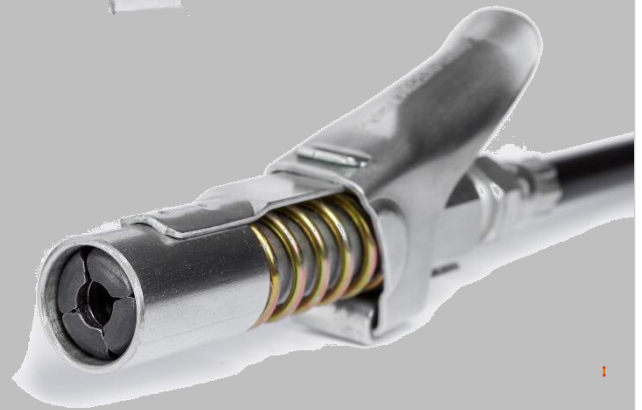
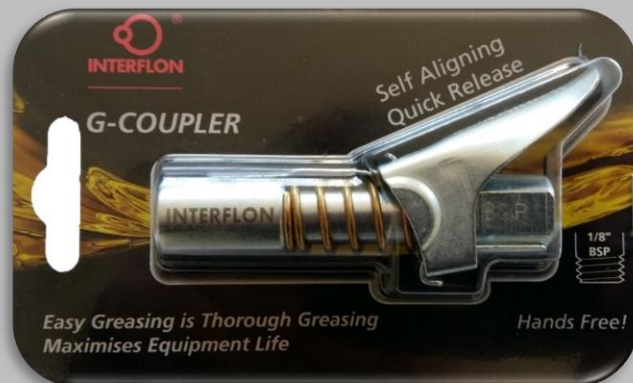
## Application; Interflon G-COUPLER

- Hands free use during lubrication
- Does not leak, even when used at an angle
- Prevents unnecessary waste of grease
- Integrated non-return valve
- Withstands high pressure
- Easy to connect
- Can be used up to 690 bar
